**NASA CONTRACTOR  
REPORT**

NASA CR-2884

**LOAN COPY: RETURN TO  
AFWL TECHNICAL LIBRARY  
KIRTLAND AFB, N. M.****MODEL PREDICTIONS OF WIND  
AND TURBULENCE PROFILES  
ASSOCIATED WITH AN ENSEMBLE  
OF AIRCRAFT ACCIDENTS**

AERONAUTICAL RESEARCH ASSOCIATES OF PRINCETON, INC.

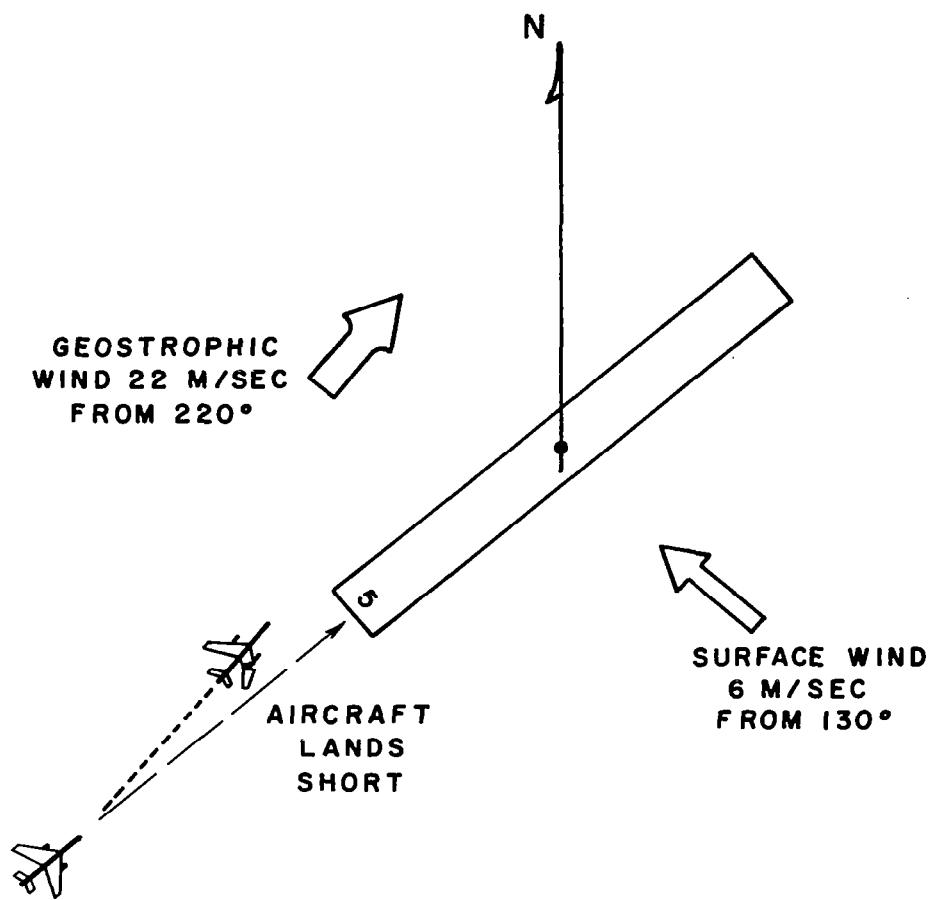
Figure 5.1.1. Aircraft-runway-winds orientation diagram for Raleigh-Durham, N.C., April 2, 1970 accident.

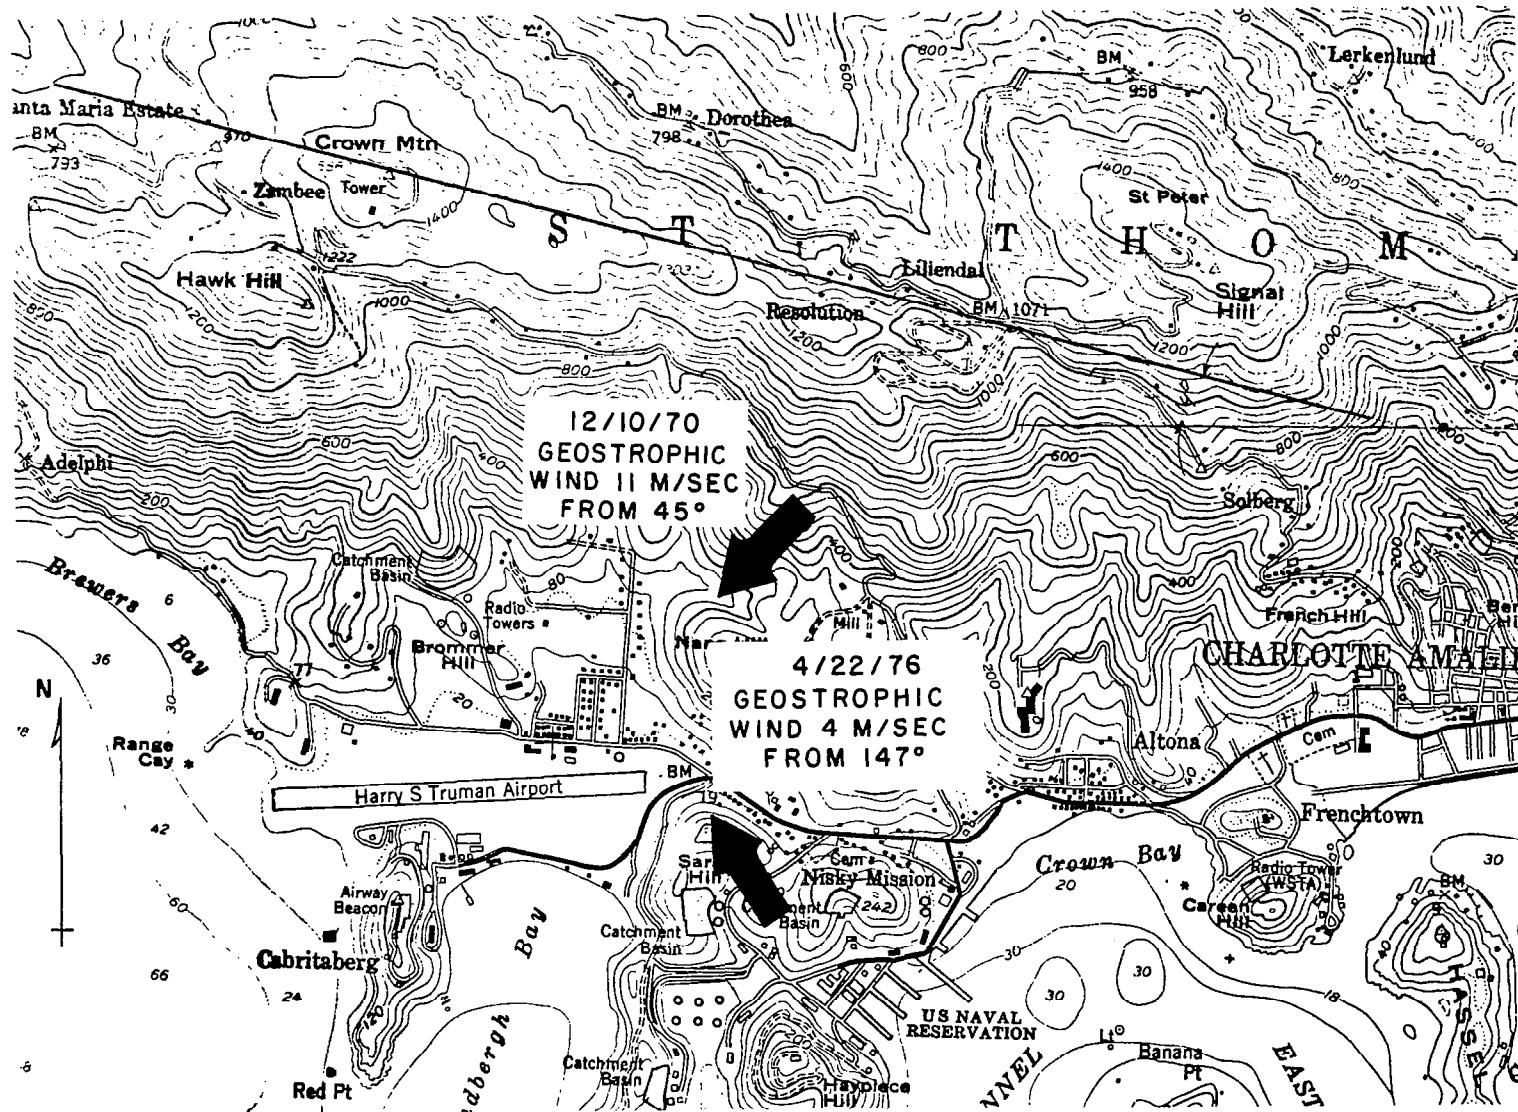
Figure 5.2.1. Airport-topography-wind orientation drawing for the two St. Thomas, V.I. accidents.
